Construction Assessment of the CMSD Landfill Cap Repair

Ormet Primary Aluminum Corporation Hannibal, Ohio

31 March 2008

ICF International 33 Hayden Ave. Lexington, MA 02421 USA

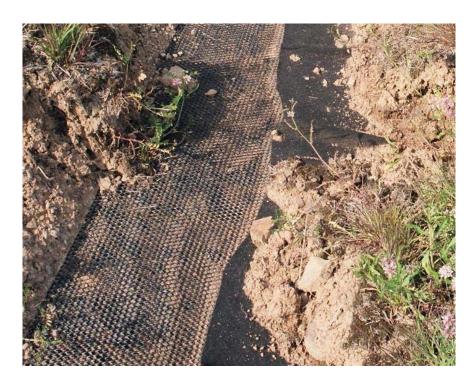
Photo 1: Exposed geonet due to slide along geotextile and geonet interface

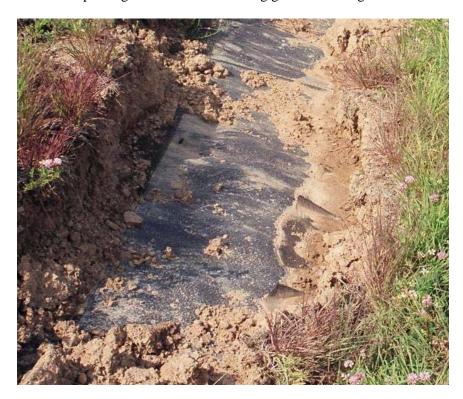
Photo 2: Exposed geomembrane due to slide along geonet and geomembrane interface

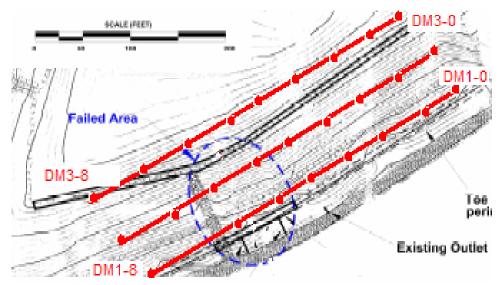
Figure 1: Displacement Monitor Locations and Proposed Numbering System

Figure 1, below, shows the approximate locations for the displacement monitors and the proposed numbering system. Each monitoring stake must be clearly marked in the field.
